Hydro geological Studies of Chitoda Village from Yawal Taluka of Jalgaon District, Maharashtra

Abstract

The present paper deals with the hydro-geological studies of a village in Jalgaon district of Maharashtra. Data on geological conditions, soil, hydrology and existing groundwater occurrences have been integrated for management of aquifer for drinking water requirement in the area.

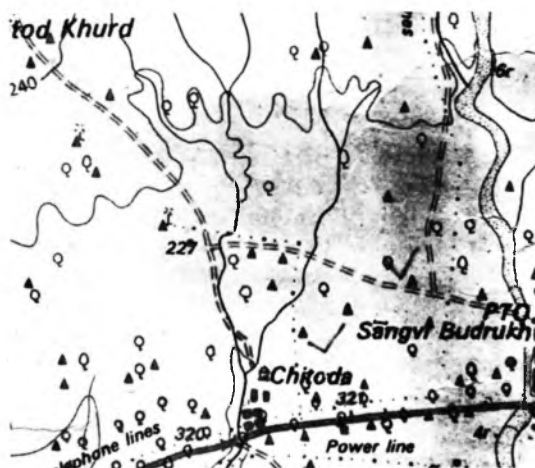
Physiography of this village is typical and forms valley fill and in Northern part of the village is situated at an elevation of > 237.00 meters altitude and is moderately sloping towards South direction attending minimum elevation 220.00m .The slop of the area is 5 to 6 %. There is drop of 17 m in ground level between North and Southern part of the village.

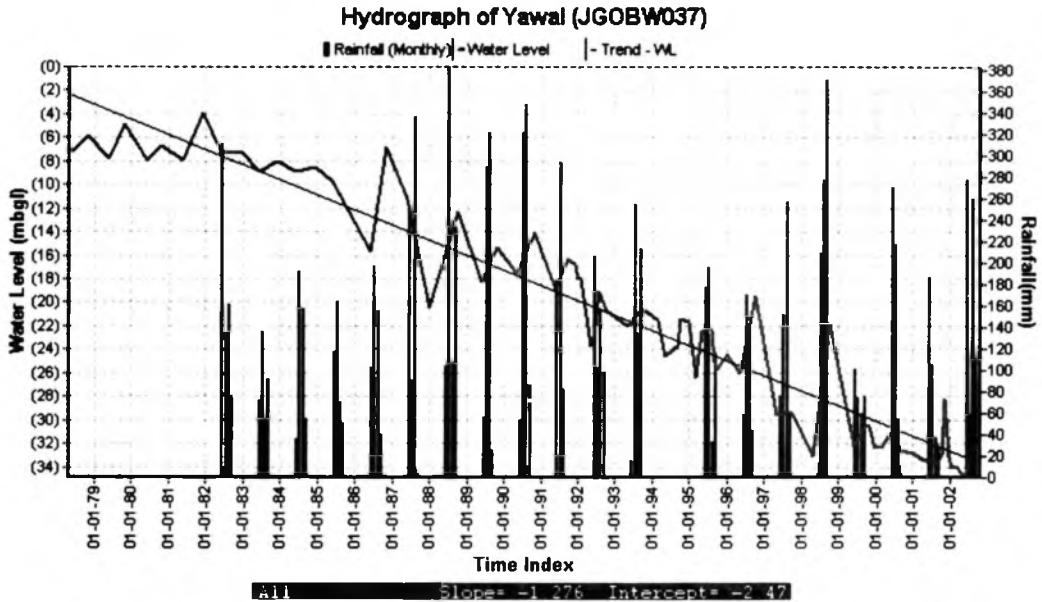
There are 46 wells existing in the village. Out of them 37 wells and 4 tube wells are used for irrigation purpose. Out of them 37 are irrigation wells and 16 wells are inventoried. The well density in this part is 5.07 wells/ Km². The village is electrified and there is all irrigation wells fitted with electric motors. In general the depth of the wells is ranging from

45 Mt. to 66Mt with the diameter ranging from 2.00mt to 3.80Mt. Water tables in the village exist at a depth of 35.30 to 65meter below ground level during winter and 34 to 64meters during summer.

From the hydrograph it is observed that water level decline trend @ of 0.50 to 1.0 m per year it causes to increase in well depth for 1 to 1.50 m per year.
